ANALYSIS STUDY OF DUST SEAL GAP DEFECT OF A FRONT FORK

¹Prof.M.S.Wani , ²Swapnil Phokne, ³Sonali Vyavahare

Mechanical Department, Guru Gobind Singh Polytechnic, Nashik, Maharashtra, (India)

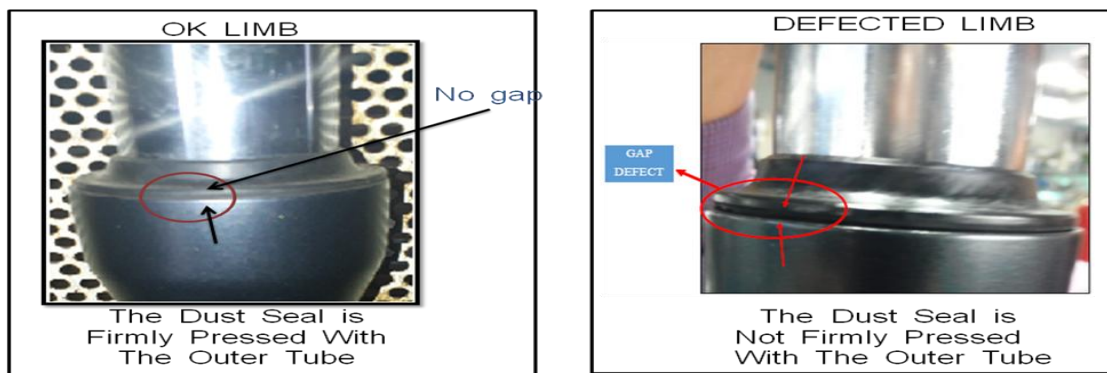
IV. DEFECT DESCRIPTION

The dust seal gap defect is really undesirable as it affects the functionality of the front fork. It allows the seepage of dust inside and affects the retraction of the limb which is one of the core functionality of the limb in the motorcycle. The above figure shows two limbs. Out of which the first limb is OK limb as the dust seal is firmly pressed with the outer tube. Whereas the second limb is a DEFECTED limb as there exists a gap between the dust seal gap component and the outer tube. The gap may be uneven meaning only existing in some sides of the seal or in some extreme cases, the gap maybe present throughout the circumference of the seal. Most of the defects are of the former case as described above.

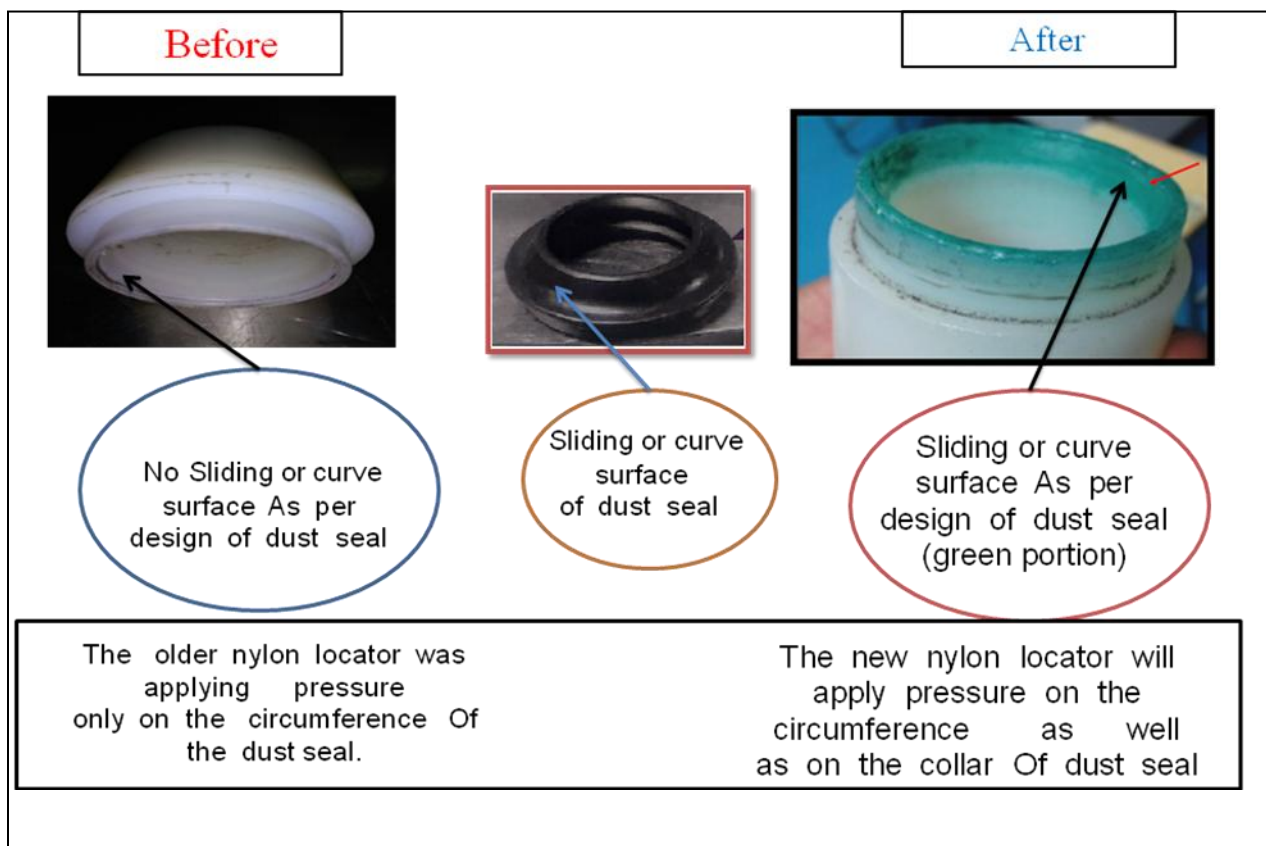
CHANGE IN DESIGN OF NYLON LOCATOR

The moment of truth for the crucial operation concerning our project is when the nylon locator touches the dust seal component and in-direct the pressure is applied upon the points of contact. We observed that the existing nylon locator was only applying pressure on the circumference and not on the collar of the dust seal. This feedback was taken by the quality department and then they came up with a modified nylon locator as shown below :

The above figure shows the design modification of the nylon locator. In the old nylon locator the pressure was applied only on the circumference of the dust seal during the dust seal pressing operation due to which the dust seal would buldge out and there would be seen a gap. So a new nylon locator is designed as per the design of the dust seal, a sliding or curve surface is provided on the new nylon locator. The green colour as seen in the new modified nylon locator shows a indication of sliding or curve surface so produced in the new design of nylon locator. The result was seen that the pressure was applied on the circumference as well as on the collar of dust seal during the dust seal pressing operation process on the machine.

Thus the proposed had desirable change in rejection quantity.
