## Failure Analysis of Cam gear & Auxiliary gear

A.M.Tripathi

*Department of Mechanical Engineering, A.I.M.T., Greater Noida, India*

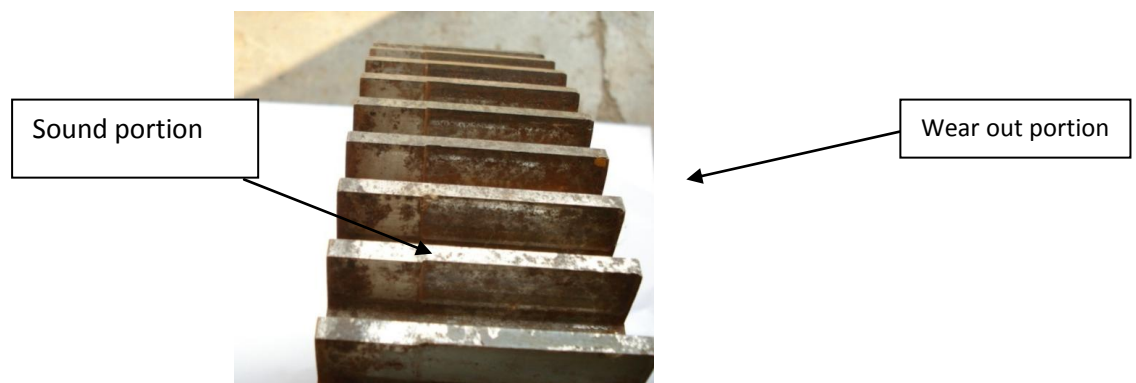
#### Sample No. 232/09/1 (Cam Gear)

The top portion of cam gear was found worn out partially to a length of 51.5 mm and up to a depth of 0.5 mm in all the teeth as shown in (fig.1)

Fig.1 photograph showing wear teeth of cam gear

The findings indicate that medium carbon chromium alloyed steel having the ability to harden throughout the section was used for cam gear. This gear was found to be through hardened where the hardness varied from 41-38 HRC. The findings in respect of auxiliary gear reveal that a low carbon, Ni-Cr alloyed steel of case carburising quality was used for manufacturing auxiliary gear and the gear was found to be case hardened up to the depth of 1.20 mm with the surface hardness of 51 HRC. Thus, the cam gear with a surface hardness of about 41 HRC on the teeth and the auxiliary gear with the surface hardness of 51 HRC on teeth were mating each other during service. However, the wear on the top surface of all the teeth of cam gear covering partial length shows some mismatch between the two. Had the difference in hardness and chemical composition been the predominant factors for wear of cam gear, the gear should have been worn out on the entire surface and length of all the teeth.

1. The partial wear on up to certain length of all the teeth of cam gear may be attributable to the combined effect of mismatch between the mating gears and lower hardness of cam gear as compared to the auxiliary gear.
2. It is advised to modify the heat treatment of cam gear so as to approximately match the teeth hardness with the mating auxiliary gear. The cam gear made out of medium carbon chromium alloyed steel can be subjected to hardening and tempering in the core and induction hardening in the teeth to achieve about 30-35 HRC in the core and 40+5 HRC in the case of teeth.
3. The fitments aspects need to be looked into so as to avoid wear due to mismatch of gears.

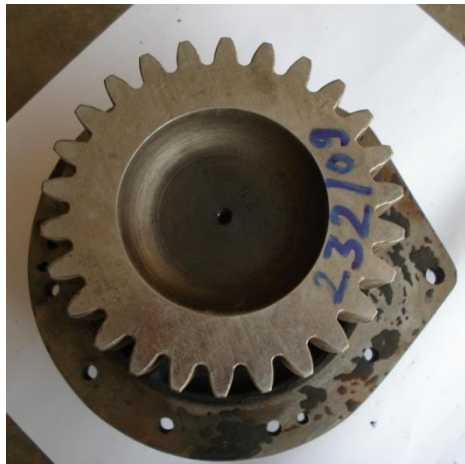
#### Sample No. 232/09/2:

There was not any deformation or breakage noticed in this sample. Gear was received in assembled condition.

Fig.2 photograph showing auxiliary gear.

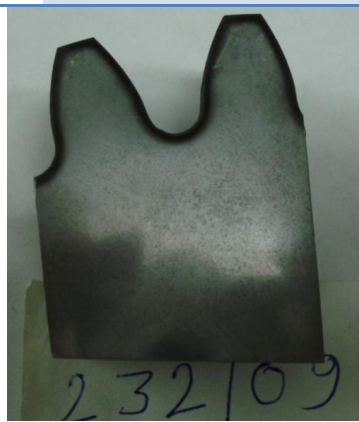
Sample No.	Case Depth (mm)	Specified
232/09/1 (cam gear)	Nil	Not specified
232/09/2 (auxiliary gear)	1.2	Not specified

Fig.3 Photograph showing case depth of sample no.232/09/2.

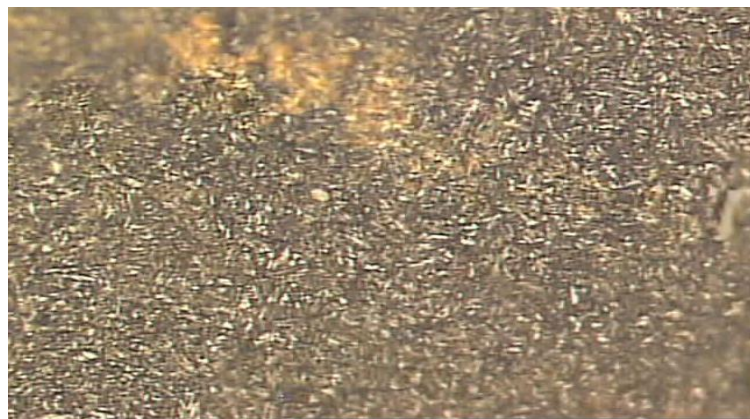
Sample No.	Observation
232/09/1 (cam gear)	Revealed tempered martensite (fig.4)
232/09/2 (auxiliary gear)	Case – Revealed martensite (fig.5). Core – Revealed mixture of bainite and martensite. (fig.6)..

Fig.4 Photomicrograph showing tempered martensite structure in X500 sample no.232/09/1 (cam gear).

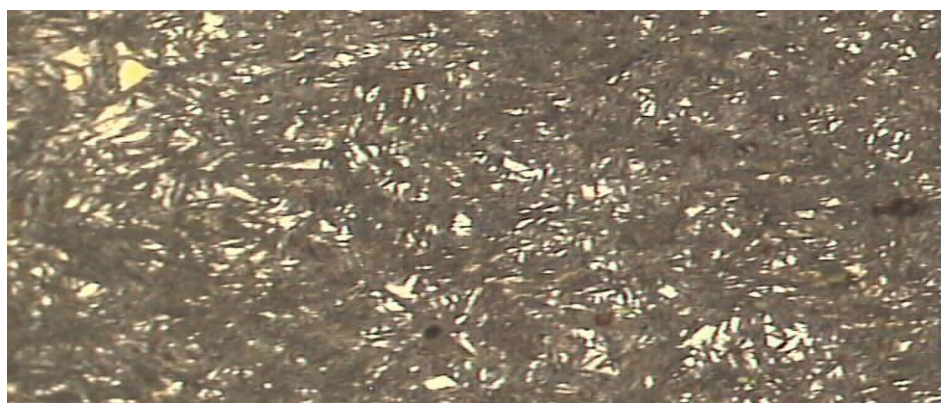
Fig.5 Photomicrograph showing martensite in the case of X500 sample no.232/09/2 (auxiliary gear).

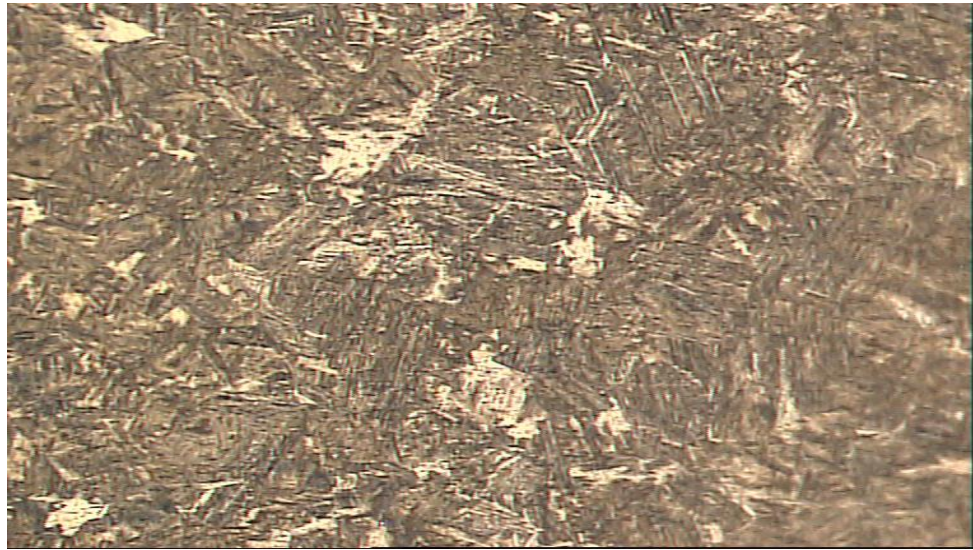
Fig.6 Photomicrograph showing mixture of bainite & martensite X500 in core of sample no.232/09/09/2 (auxiliary gear).
