Morphological Analysis of Glass/Jute/Epoxy Composite Fractured Surfaces

Khushi Ram^{1*}, Pramendra Kumar Bajpai¹

¹NetajiSubhas Institute of Technology, Dwarka, Delhi-110078

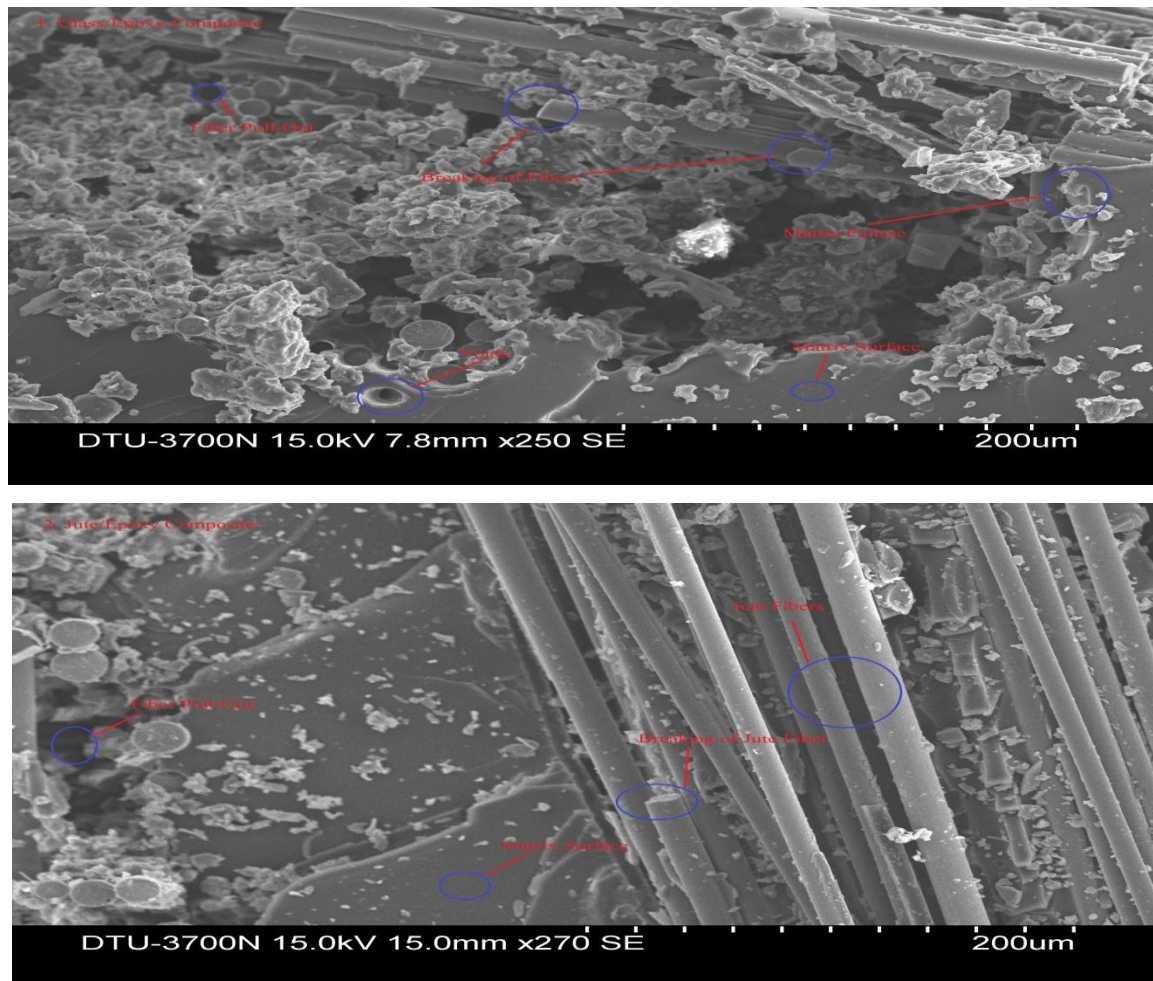
Figure 1 shows the fractured surfaces of Jute/Glass/Epoxy composite surfaces after tensile test. The fiber pull-out, breaking of fibers and voids are shown in the images. Ramnath et al. [5] investigated morphological characteristics of abaca/jute/epoxy composite. The authors showed that the jute had better adhesion with epoxy matrix which decreased the chances of fiber breaking and pull-out of fibers. The tensile properties of the developed composites are affected by the presence of any impurity in fibers which results in poor adhesion between fiber and matrix surfaces.

Figure1. SEM images of tensile fractured surface of Glass/Jute/Epoxy Surfaces

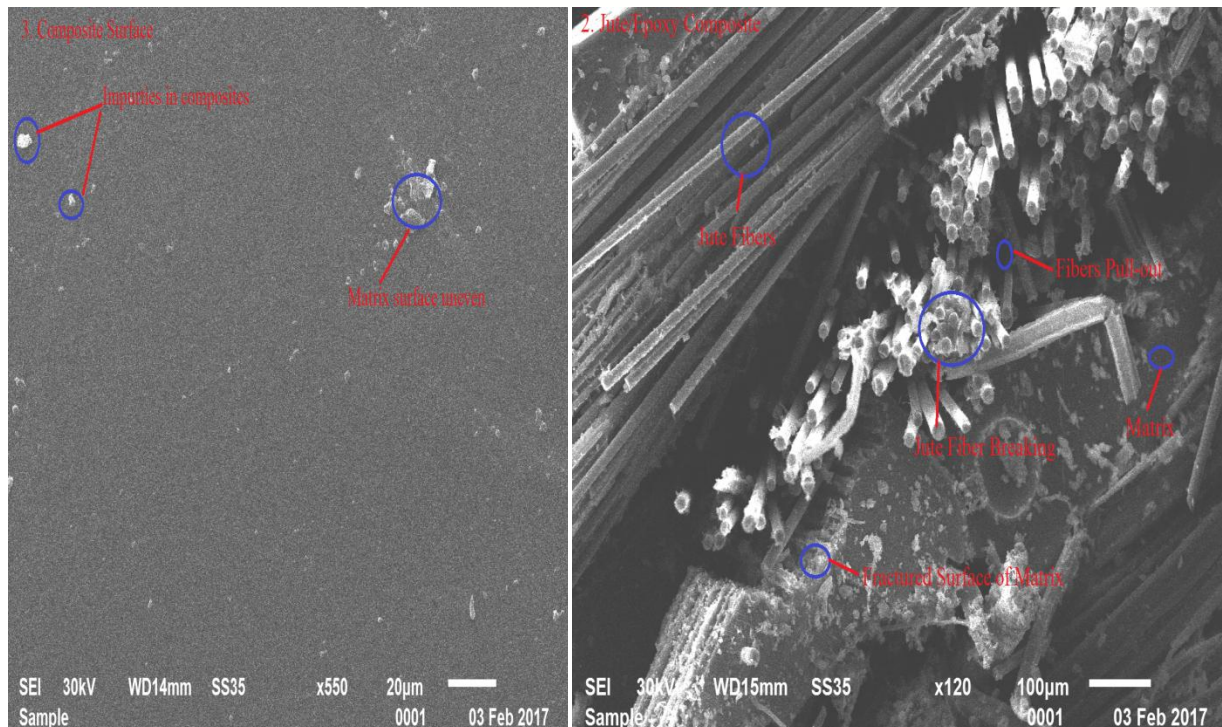
The SEM micrographs of flexural fractured composite specimen and composite surface are shown in figure 2. The composite surface shows that there is less voids on composite surface and no other impurities are present. The flexural fractured surface shows fiber breaking and pull out of fiber during three point flexural tests. Fiber provides the flexural strength to the composite and matrix holds the fibers together. If the fiber and matrix surface are not properly in contact with each other, it will result in decrease of flexural strength.

Figure2. SEM images of composite surface and flexural fractured Jute/Epoxy composite.

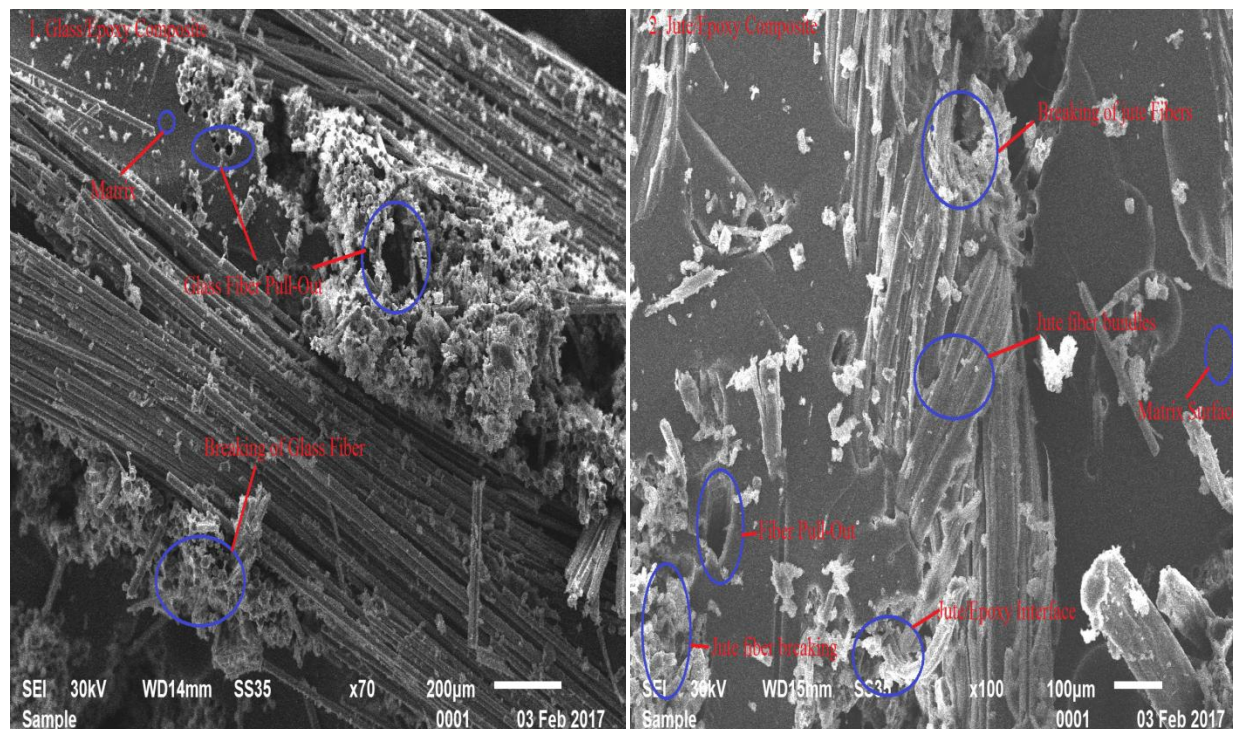
The micrographs of impact fractured surfaces of glass/jute/epoxy composites are shown in figure 3. The micrographs show the fiber breaking, fiber pull-out, fiber/matrix interface. Chaudhary et al. [6] studied the micrographs of impact fractured surfaces of jute/hemp/flax reinforced epoxy composites. The authors analyzed that fiber pull due to weaker interfacial shear strength decreased the impact strength of the developed composites.

Figure3. SEM images of impact fractured glass/jute/epoxy composite.
