# PROPOSAL OF A SCHEME FOR CIRCULATION OF WATER IN THE TANKS OF BRAHMA SAROVAR AND SANNIHITH SAROVAR

<sup>1,2</sup> Department of Civil Engineering, NIT Kurukshetra, (India)

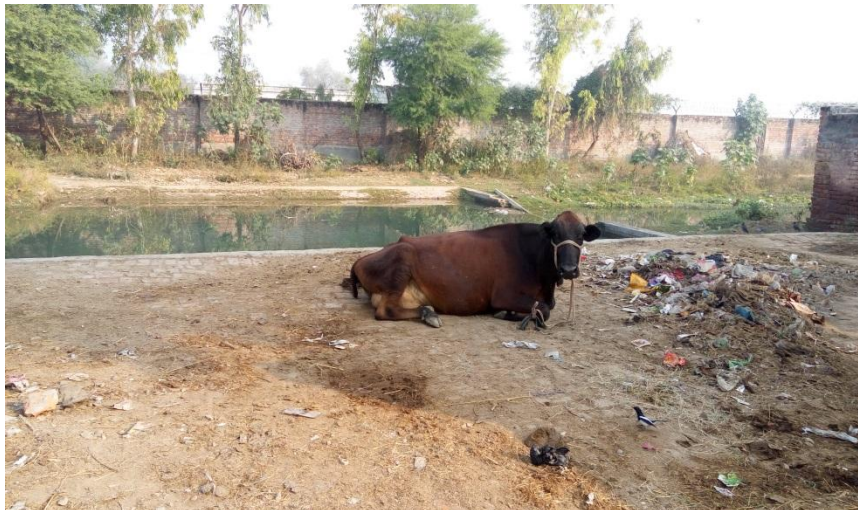
**Figure 3:** Cattle Farming at Mirzapur village

On its onward journey a total of 50 Cusecs of water is being carried by Thanesar Distributary which is an open channelled lined canal. Out of this 50 cusecs, 20 Cusecs are pumped into Brahma Sarovar and the rest 30Cusecs is carried forward for the purpose of cultivation and other needs. This canal on its way to Brahma Sarovar passes through Mirzapur Village, Bhatta Colony and Kurukshetra University. In Mirzapur village it is being observed that the villages carryout cattle farming on the banks of the canal (fig 3) and it is also seen that they have dumped solid waste into the canal(fig 4). The canal before entering Kurukshetra University has a ghat where laundry work for a large number of clothes is carried out resulting in polluting the water with chemicals, detergents etc. (fig 5).

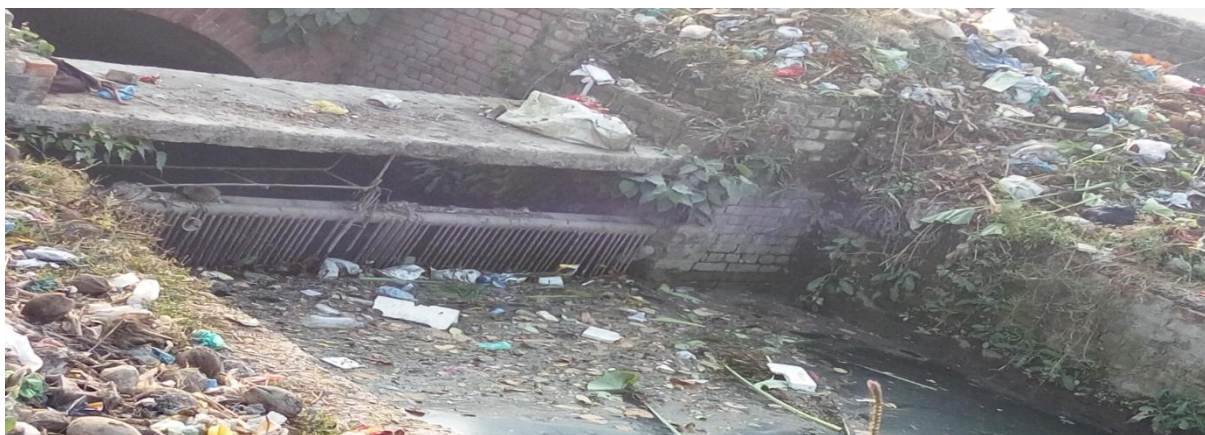
**Figure 4:** Garbage dumped in the distributary

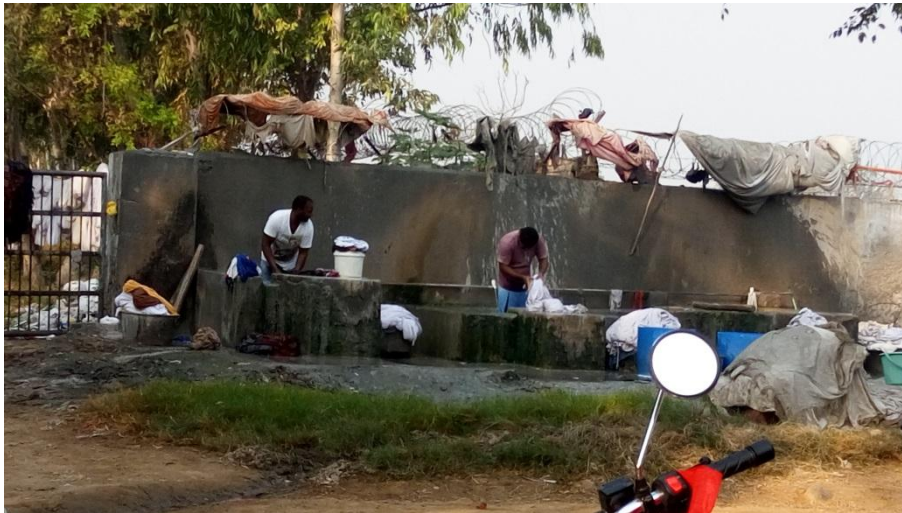
**Figure 5:** Laundry on the banks of distributary
