ANALYSIS STUDY OF DUST SEAL GAP DEFECT OF A FRONT FORK

¹Prof.M.S.Wani , ²Swapnil Phokne, ³Sonali Vyavahare

Mechanical Department, Guru Gobind Singh Polytechnic, Nashik, Maharashtra, (India)

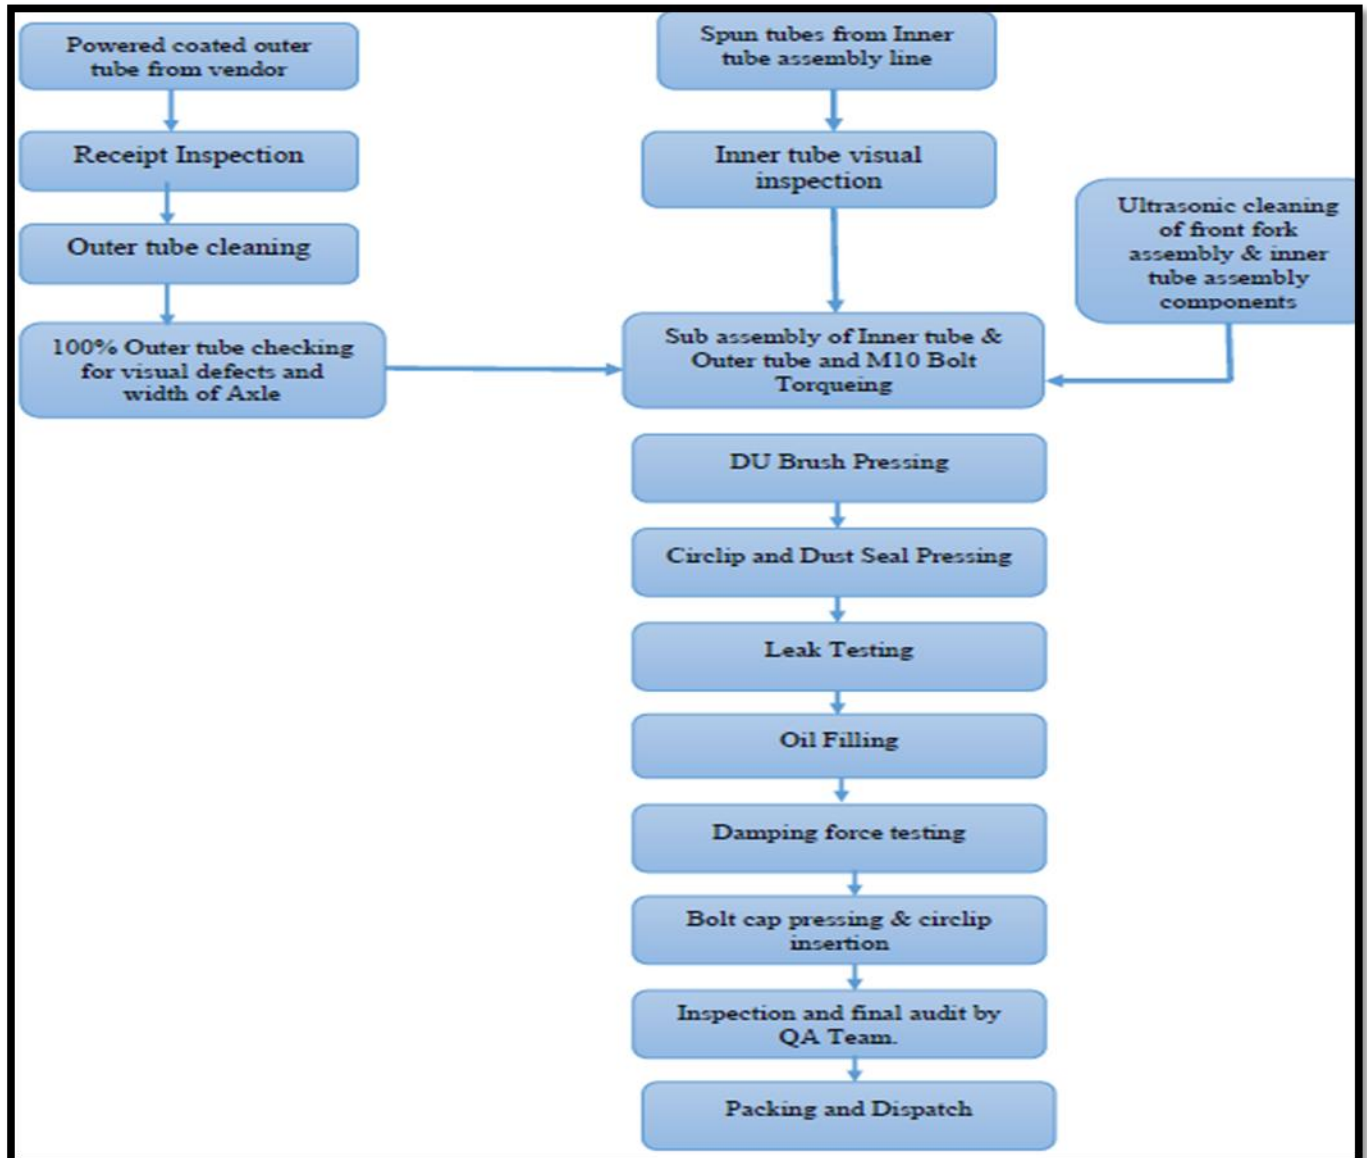
VIII. PROCESS FLOW CHART FOR PRODUCING A FRONT FORK

The fishbone diagram illustrates the causes of a Dust Seal Gap, categorized into four main areas: MACHINE, METHOD, MAN, and MATERIAL. The central spine points to the effect, DUST SEAL GAP.

- MACHINE**
 - Low Pressure
 - Improper application of pressure through nylon locator.
 - Pressure in Leak testing process
 - Groove Tool
- METHOD**
 - Duration for which pressure is applied on dust seal is less.
- MAN**
 - Operator forget to insert circlip.
- MATERIAL**
 - Deformation of metal ring inside dust seal on application of pressure.
 - Width of circular grooves of outer tube.
 - Material specification of Dust Seal as supplier changed.
 - Flatness of circlip

IMPACT	HIGH	1)Material specification of dust seal as supplier changed	1)Improper application of pressure through nylon locator 2)Duration for which pressure is applied on dust seal is less
	LOW	1)Deformation of metal ring inside dust seal on application of pressure 2)Flatness of circlip	1)Low Pressure 2)Width of circular grooves of outer tube
		LOW	HIGH
IN OUR CONTROL

S.No	Causes	Actions taken	Output
1	Low pressure	Increased pressure from 4 Bar to 6 Bar	No significant change in defects
2	Improper application of pressure through nylon locator	Design modification of nylon locator	Significant reduction in defects
3	Duration for which pressure is applied on dust seal is less	Increased timings from 2 sec to 4 sec	Significant reduction in defects
4	Deformation of metal ring inside dust seal on application of pressure	Contact Supplier	Organization to take forward due to delay in response from Vendor
5	Width of circular grooves of outer tube	Change in the width and depth of the grooves	No significant change in defects
6	Material specification of dust seal as supplier changed	Contact Supplier	Organization to take forward due to delay in response from Vendor
7	Flatness of circlip	Contact Supplier	Organization to take forward due to delay in response from Vendor
