ANALYSIS THE FAILURS IN BOILERS SUPER HEATER TUBE

This paper presents the failure investigation of superheater tubes. Samples were collected from one of the coal fired power plants in Mettur, namely, mettur thermal power station plant I. After eight years of non-continuous services of three boilers, welded support-clips were completely separated (detached) from superheater tubes, which caused the wall thinning. Collected failed samples were undergone several experimental investigations including visual inspection, thickness measurement, Vickers hardness testing, and microstructure evaluation. The results revealed that some cracks were initiated at the heat-affected zone (HAZ) and propagated partly throughout the weld metal. The estimation on operating temperature and operating hoop stress show indication that the specimen may experienced a hig operating temperature. Other findings confirmed that the detachment of welded support-clips from Superheater tubes may also caused by dissimilar metal weld (DMW) failure due to the differences in expansion properties of parent metal and weld metal

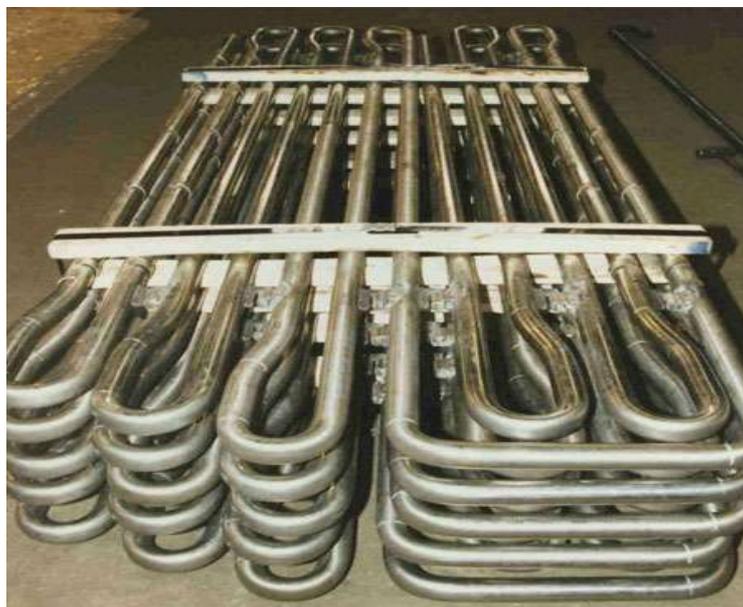
A superheater is a device used to convert saturated steam or wet steam into superheated steam or dry steam.

Superheater tubes in a comprehensive range of stainless steels and nickel alloys covering outside diameters 12 to 260 mm (0.472 to 10.24 in.).
